Group Chairman's Factual Report

Engineering and Stability

M/V Lady D Capsizing

Accident Number: DCA-04-MM-015

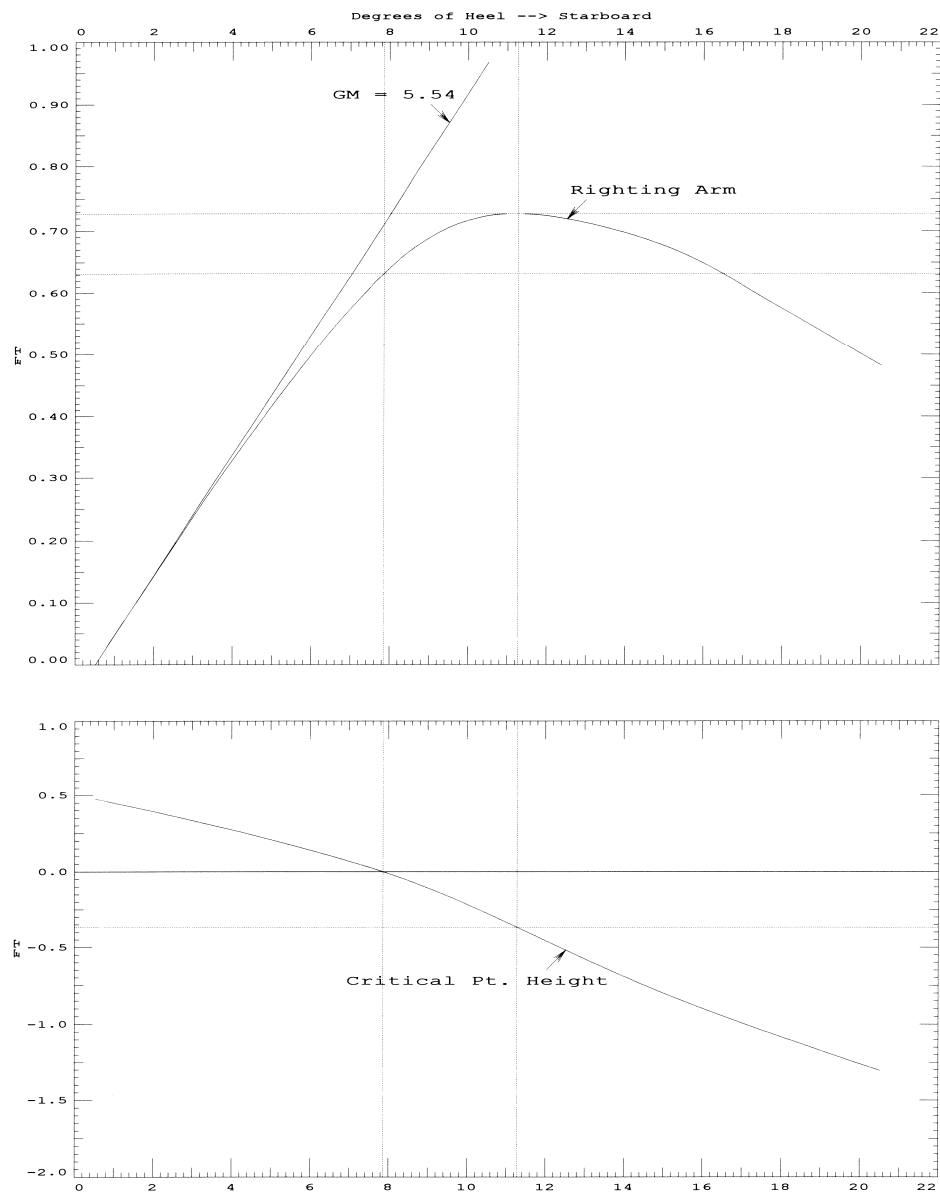
Figure 1 - Righting arm curve

while the vessel was afloat. The vessel was floated in its damaged condition without adding any weights for the missing vessel components, such as the starboard seating bench or the deckhouse. Using GHS computer software, the static stability analysis performed on the *Lady D* (Task 2) showed that the vessel did not meet the current regulations of 46CFR 178.340 for pontoon vessels operating in protected waters with the 25 (140 lb) passengers shown on her stability letter issued on March 28, 1996. The vessel failed to meet the minimum criteria for adequate stability in both transverse and longitudinal directions.

c) Additional analysis was done for the vessel as it was actually loaded at the time of the accident, that is with an average passenger load of 168.4 lbs. As in the previous case where the vessel was loaded with 140 lb passengers, the vessel failed to meet the stability criteria. The righting arm curve for the vessel was shown to be approximately 0.73 feet at 11.3 degrees of heel.
